# STICKLE POND DAM

## PHASE I INSPECTION REPORT NATIONAL DAM SAFETY PROGRAM

NJ 00285

JULY 1978

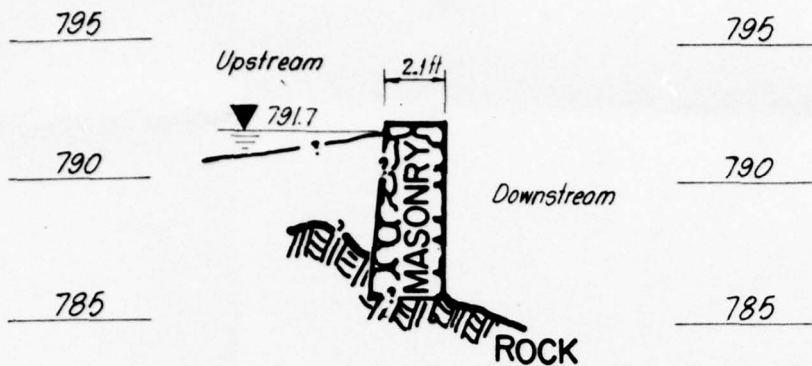
**SECTION D-D'**

SECONDARY SPILLWAY  
CROSS SECTION

5. The secondary spillway should be strengthened by means of downstream support. This support could be provided by means of Gabions pinned to the rock with permanent wedges inserted and fixed between the Gabions and the downstream face of the spillway. This should be done soon.

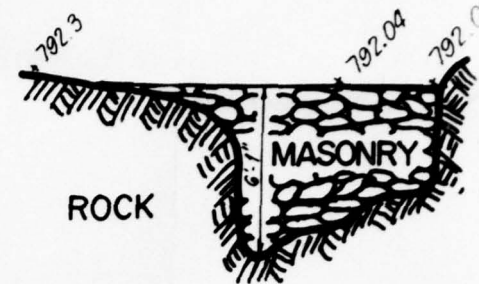
**SECTION B-B'**

SECONDARY SPILLWAY  
DOWNSTREAM ELEVATION

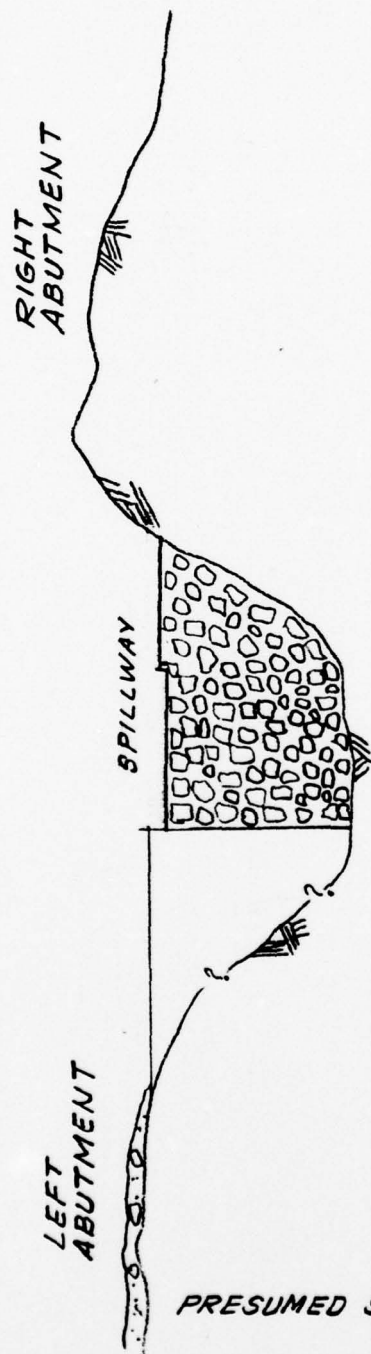
Fig 4

DIAGRAMMATIC SKETCH  
STICKLES POND DAM  
(NO SCALE)

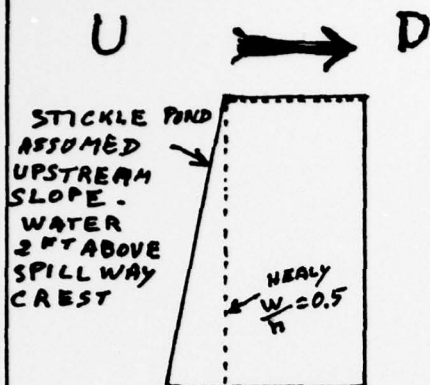
SAFETY FACTORS  
SLIDING | OVERTURN

STICKLE POND ASSUM. (A)	✓ 1.50	✓ 1.22
HEALY $\frac{W}{H} = .5$ CASE 3	1.50	✓ 1.80
STICKLE POND ASSUM. (B)	✓ 1.50	✓ 1.80
HEALY $\frac{W}{H} = .5$ CASE 4	1.3	1.40
